# STUDY OF CORROSION OF ALUMINUM ALLOYS OF NUCLEAR PURITY IN ORDINARY WATER – PART ONE

Effects of corrosion of aluminum alloys of nuclear purity in ordinary water of the spent fuel storage pool of the RA research reactor at VINČA Institute of Nuclear Sciences has been examined in the framework of the International Atomic Energy Agency Coordinated Research Project “Corrosion of Research Reactor Aluminum-Clad Spent Fuel in Water” since 2002. The study presented in this paper comprises activities on determination and monitoring of chemical parameters and radioactivity of water and sludge in the RA spent fuel storage pool and results of the initial study of corrosion effects obtained by visual examinations of surfaces of various coupons made of aluminum alloys of nuclear purity of the test racks exposed to the pool water for a period from six months to six years.

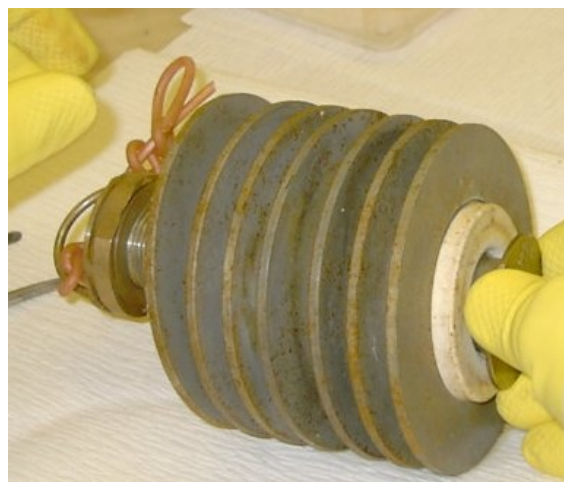
The initial visual examination of the Rack#1/CRP-I showed that the backside of the coupons was not covered by sediments (fig. 8) as it was the case at the front side of the coupons. The Rack#1/CRP-I was disassembled and all coupons

**Figure 8.** No sediments at the back side of coupons of Rack#1/CRP-I

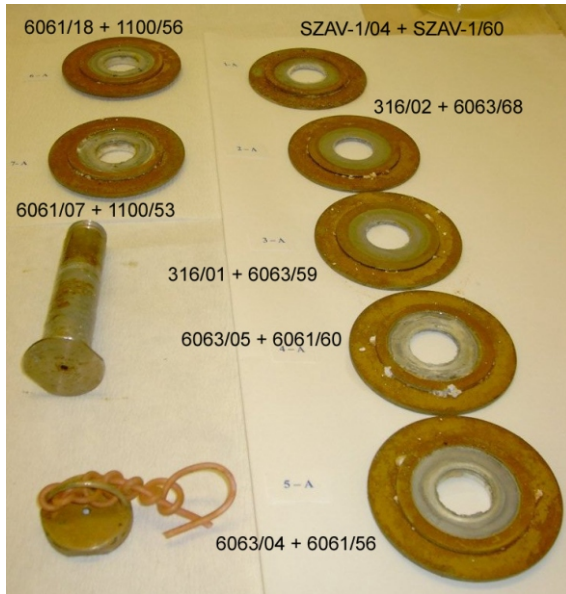
Figure 9. Front side (A) of coupon couples of disassembled Rack#1/CRP-I

Since the front side of each coupon was covered by dark-red sediment (fig. 9), effects of corrosion process could not be seen without cleaning the surfaces. Small white sediments (like jelly-mushroom type sludge) at the front side of few coupons (fig. 9) were noted. Some of these sediments were collected for further analysis. The backside of the coupons was not covered by sediment (figs. 8 and 10) and effects of the corrosion process were noted. Pitting, as a main localized form of corrosion of aluminum in water, was seen at the backside of the surfaces of all coupons. Spots of different shades of gray and black color (assumed to be aluminum-oxide) were observed at coupons too.

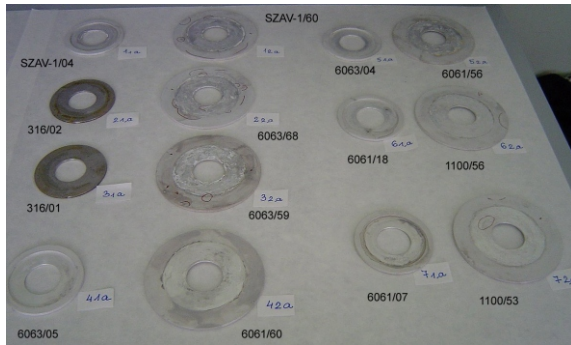
and heavily accumulated sediments, but carefully not to remove corrosion effects. Cleaned coupons of the Rack#1/CRP-I are shown in fig. 11. After cleaning process, the coupons were examined visually carefully and damaged areas were marked for further examination under microscope. Results of visual and microscopic examination will be summarized in tables later. An example of crevice corrosion process at a couple SAV-1 to SAV-1 coupons is given in fig. 12.

Figure 11. Front side (A) of coupons of disassembled Rack#1/CRP-I after cleaning

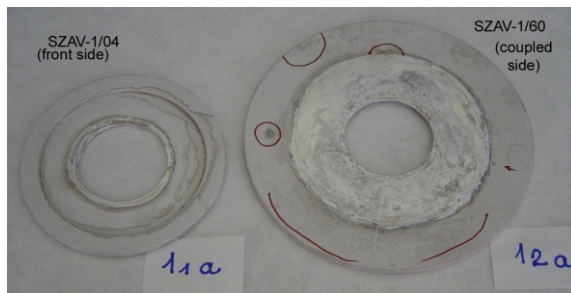
Figure 12. Front side (A) of crevice couple SAV-1 to SAV-1 coupon of RAC#1/CRP-I

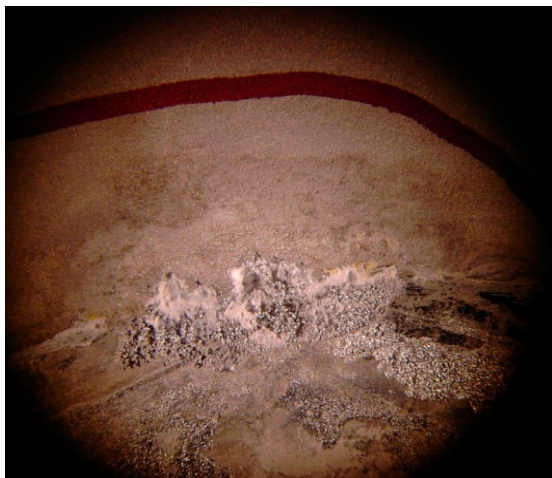
Figure 13. Galvanic corrosion with white deposit (aluminum-oxide) at coupon 6063/68

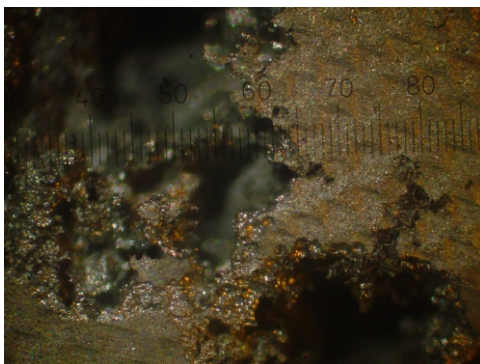
Figure 14. Deep pit of irregular shape at the front side of coupon 6061/18

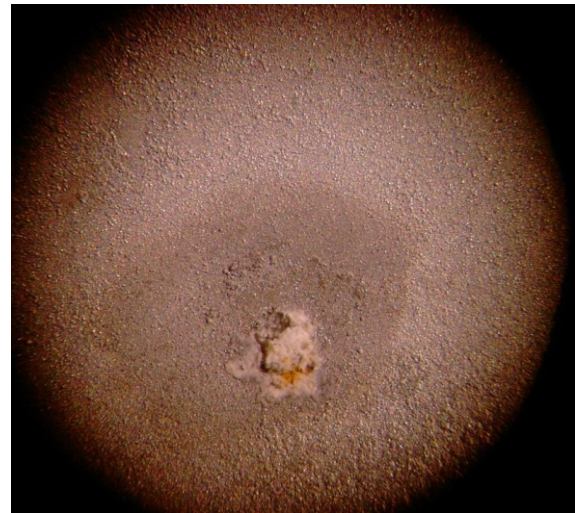
Figure 15. A pit covered with white blister at coupon SAV-1/60

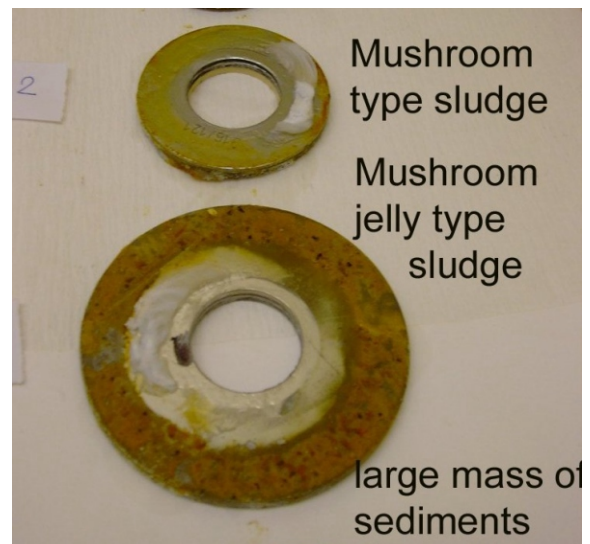
Figure 18. Mushroom-jelly type of sludge and red-brown deposits at the front side (A) of 6063/159 (lower one) and 316/121 coupon

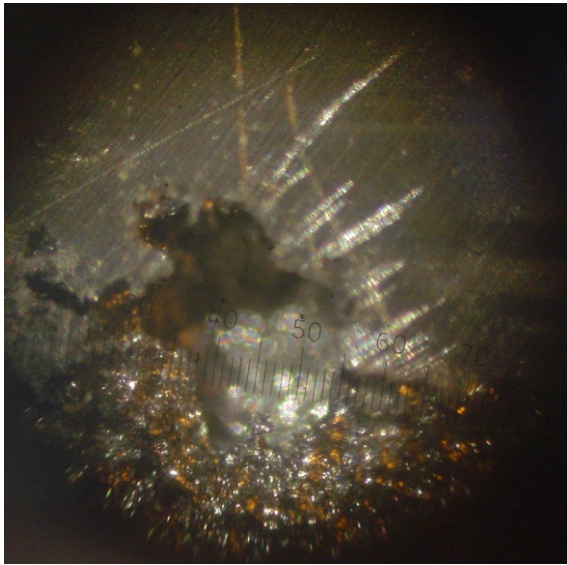
Figure 19. Galvanic corrosion and a deep pit at the front side of 6063/145 coupon

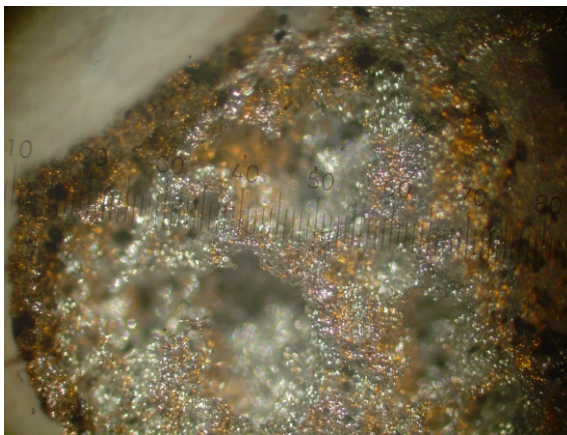
Figure 20. Very deep pits from galvanic corrosion at the backside of 6063.145 coupon

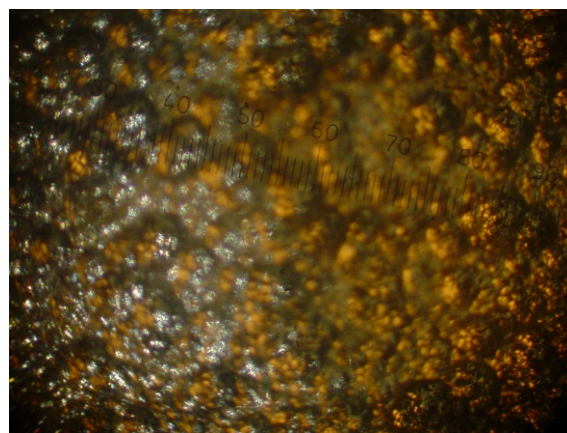
Figure 21. General corrosion under ceramic ring: spherical shaped pits at the front side of 6063.159 coupon

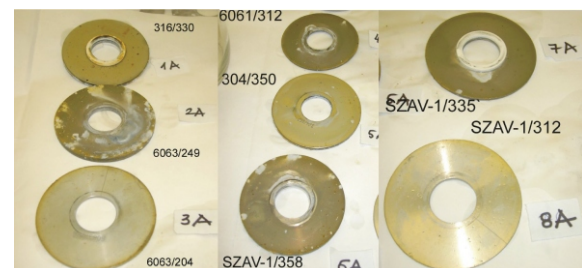
The first visual examination of the Rack#1/CRP-II showed that the front side of the coupons (fig. 23) was covered by sediments despite relatively short exposition time. There were no sediments at the backside of the coupons (fig. 24). The Rack#1/CRP-II was disassembled and all coupons were removed according to the IAEA Test Protocol. It was difficult to separate some coupled coupons, in spite of a short immersion period, and a tool had to be used. Photographs of the front (fig. 23, A) and the back (fig. 24, B) side of each coupon are presented. The number beside a coupon corresponds to the type and number of aluminum alloy or stainless steel.

Figure 23. Front side (A) of coupons of disassembled Rack#1/CRP-II

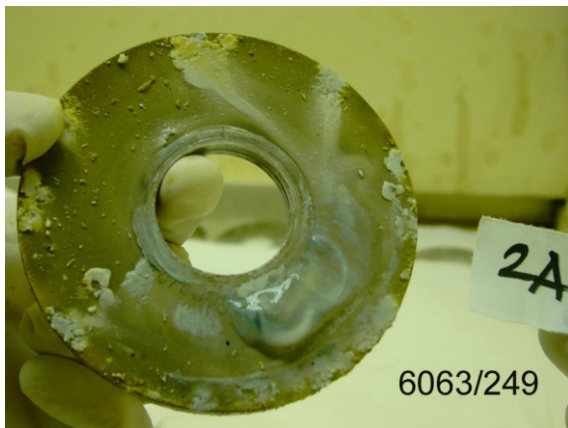
Figure 25. White, jelly-mushroom type sludge at the front side of coupon 6063/249

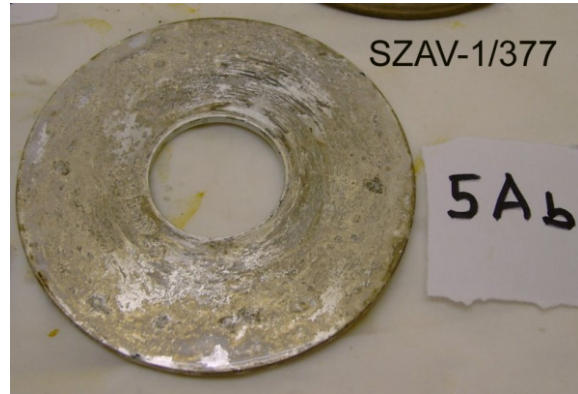
Figure 26. Galvanic corrosion at the coupled side of coupon SAV-1/377

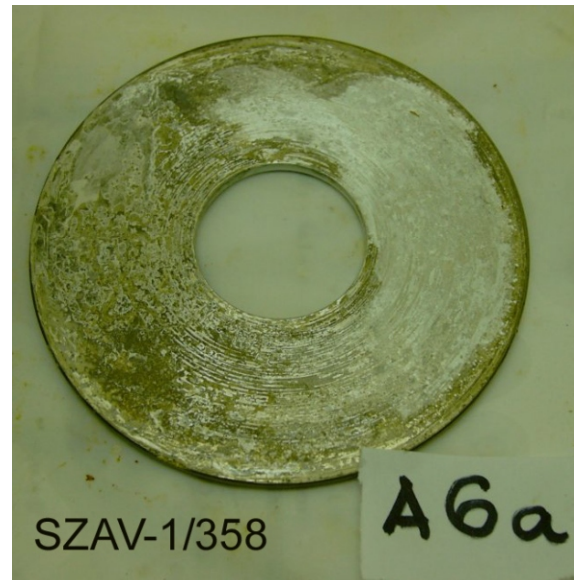
Figure 27. Crevice corrosion at the coupled side of coupon SAV-1/358

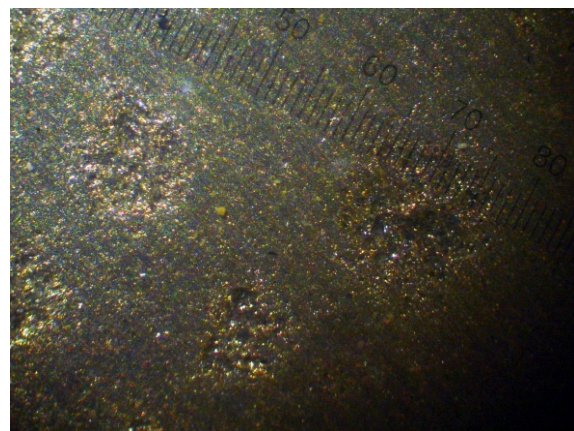
Figure 28. Deep pits at the top surface of coupon SAV-1/335 (magnification 10)

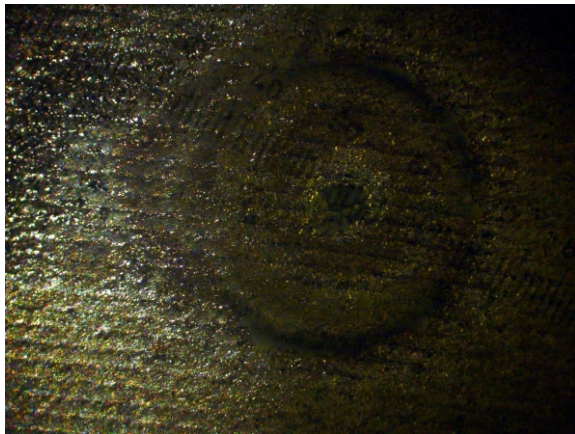
Figure 29. Circular pits at the top surface of coupon 6061/302 (magnification 10)

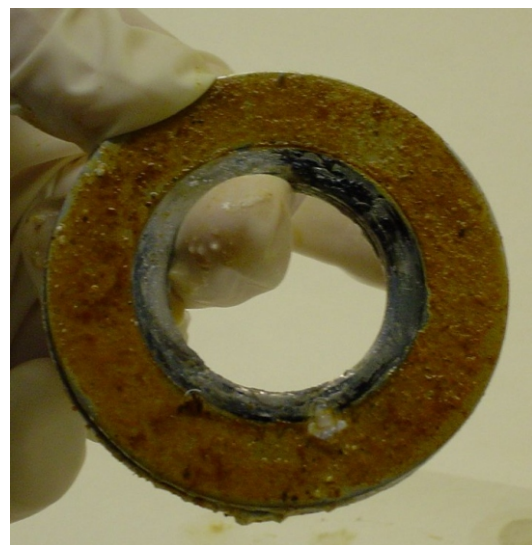
Dark-red sediments covered the front side of the coupons (fig. 32) that was exposed to water and ef-

Figure 32. Dark-red sediments at the front side of coupon 316/114

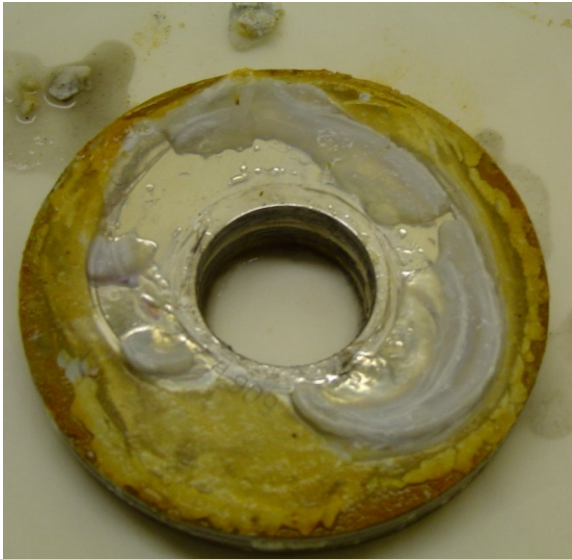
Figure 33. White jelly-mushroom type sludge at the front side of coupon 6061/212

fects of corrosion process could not be seen without cleaning surfaces. White sediments (like jelly-mushroom type sludge) at the front side of few coupons (fig. 33) and the supporter (fig. 30) of the Rack#2.2/CRP-I were noted and collected for further analysis. Effects of corrosion process were clearly noted at the backside of the coupons. The main localized form of corrosion of aluminum in water – pitting was seen at the surface of all coupons. Spots of different shades of gray and black color (assumed to be aluminum-oxide) were observed at coupons, too.

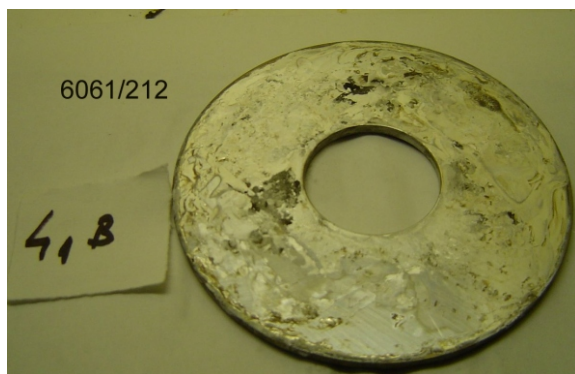
Figure 34. Crevice corrosion at the coupled side of coupon 6061/212

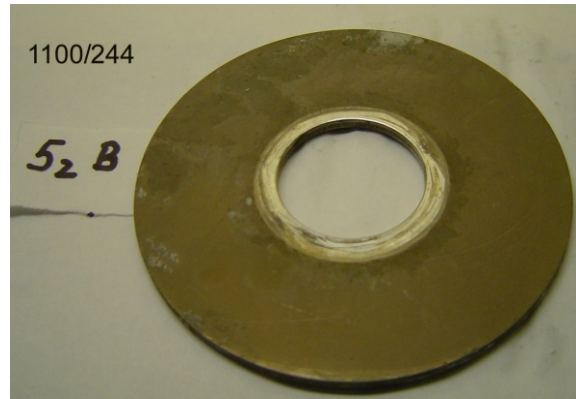
Figure 35. Uniformly dull surface of the front side of coupon 1100/244

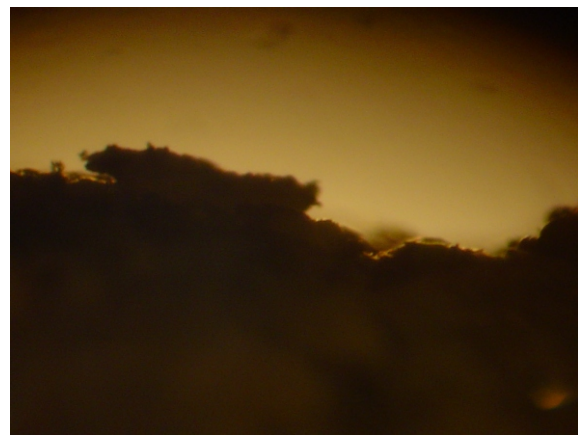
Figure 36. Corrosion at the outer edge of coupon 6063/135 (magnification 10)

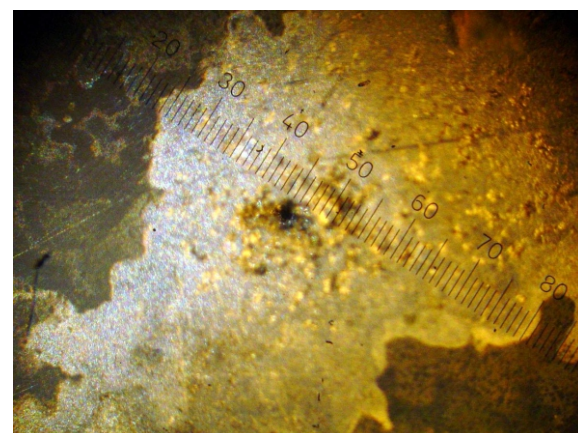
Figure 37. Galvanic corrosion at the front surface of coupon 6063.135 (magnification 10)

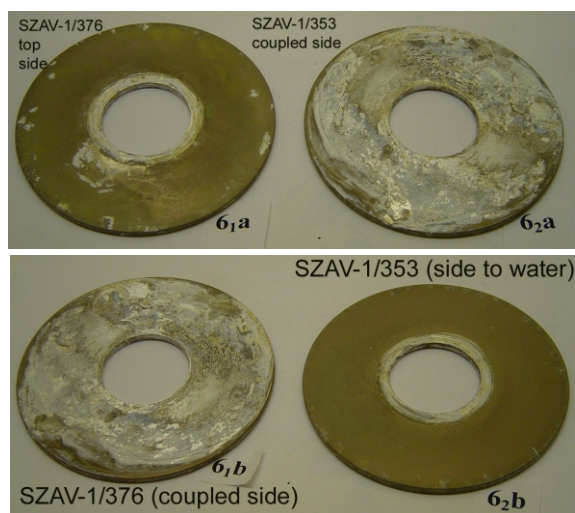
Figure 40. Crevice couples SAV-1/376 + SAV-1/353

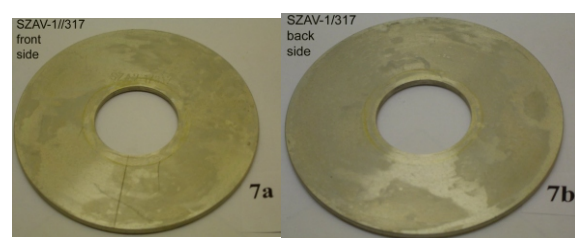
Corrosion effects were not discovered at coupon SAV-1/317 since it was pre-oxidized during manufacturing. It was scratched intentionally at the front side (shown at the left side of the fig. 41) during manufacturing process with the aim to study influence of mechanical damage to corrosion process. Visual

Figure 41. No corrosion observed at the single coupon SAV-1/317

and later microscopic examination showed that corrosion effects were not found at both surfaces or under the scratched line of the coupon SAV-1/317 or other aluminum alloy coupons that were intentionally pre-oxidized and scratched during manufacturing process.
