STUDY OF CORROSION OF ALUMINUM ALLOYS OF NUCLEAR PURITY IN ORDINARY WATER PART TWO

Key words: corrosion, aluminum alloy, SAV-1 alloy, fuel cladding, RA research reactor, ordinary water

Technical paper

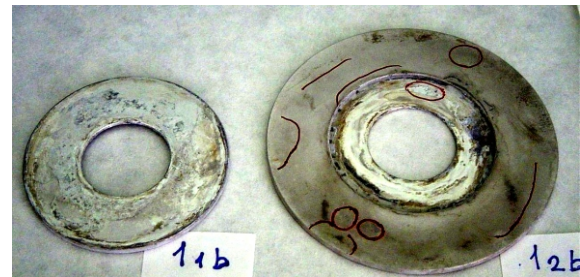
Figure 2. Visual inspection of SAV-1/04 and SAV-1/60 coupons

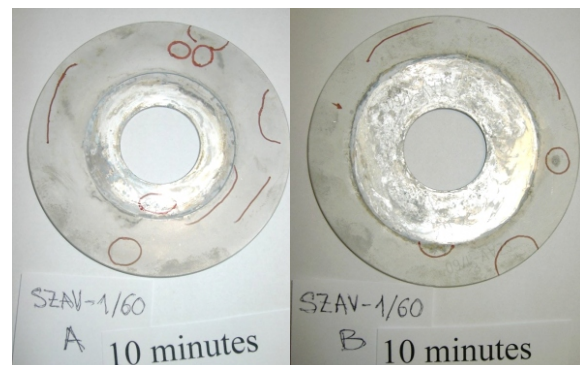
Figure 3. Front and back side surfaces of SAV-1/60 coupon

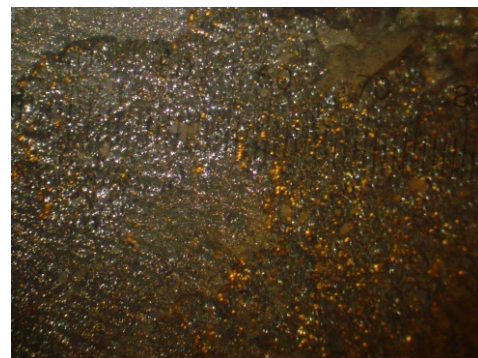
Figure 4. Pitted surface of coupon 6061/56 covered by spherical pits

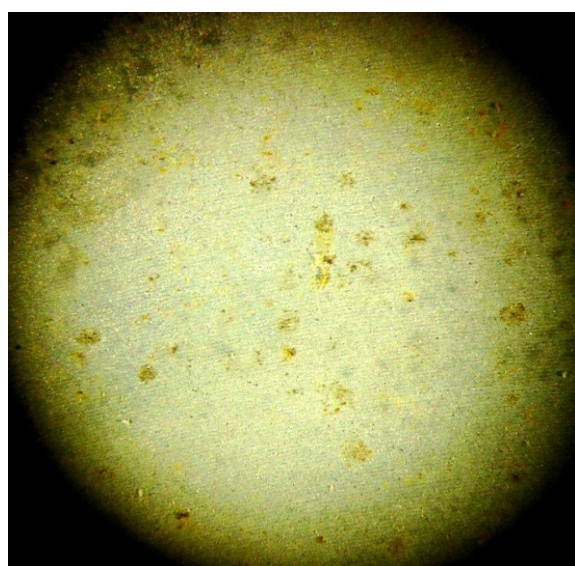
**Figure 5.** Large number of pits on front surface of coupon 6063/59

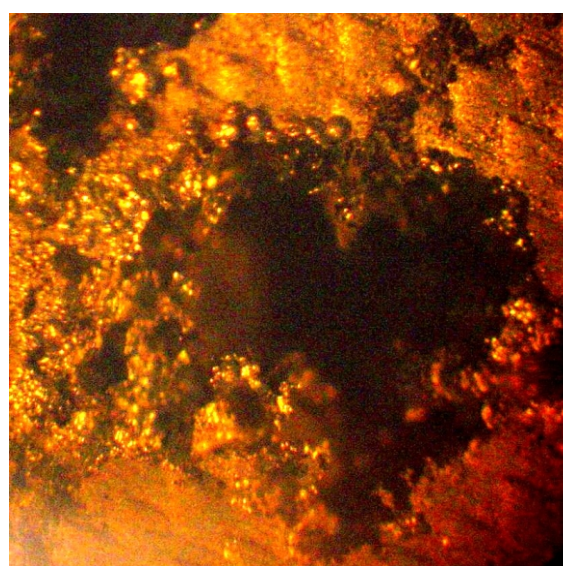
**Figure 6.** Very large pit on surface of coupon 6061/18

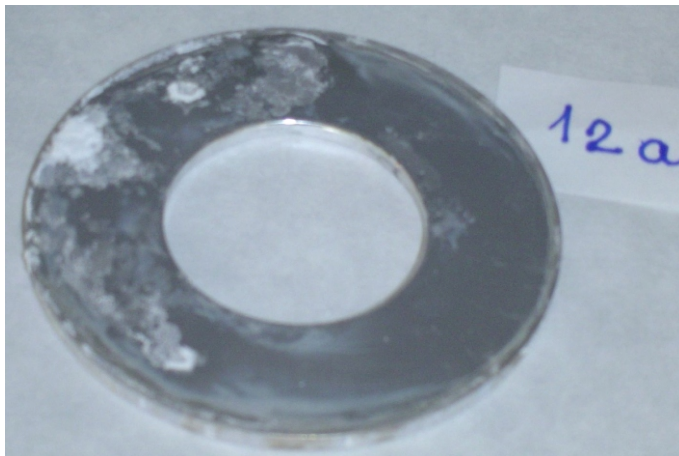
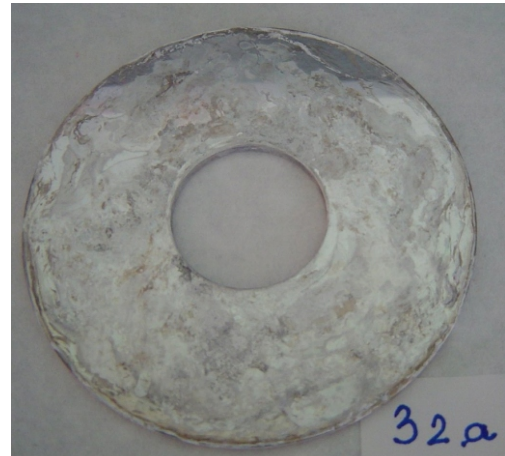
**Figure 7. Back side surface of 6063/145 (left) and 6063/196 coupons (right)**

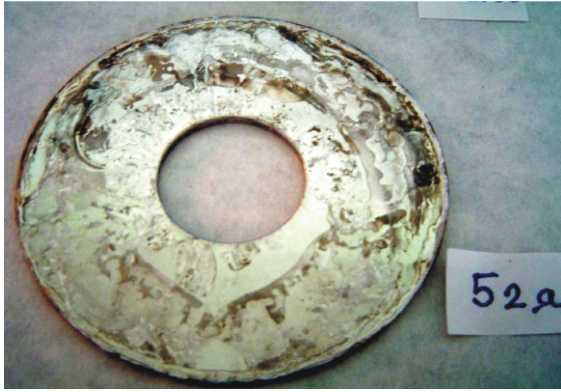
Figure 8. Back side surface of 1100/236 coupon

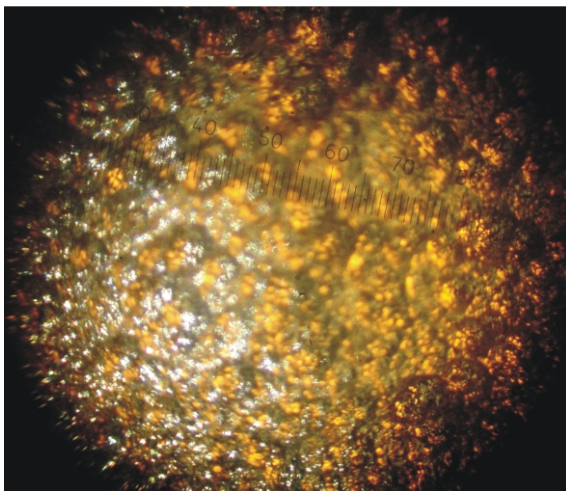
Figure 9. General corrosion under ceramic ring: spherically shaped pits at front side of 6063/159 coupon

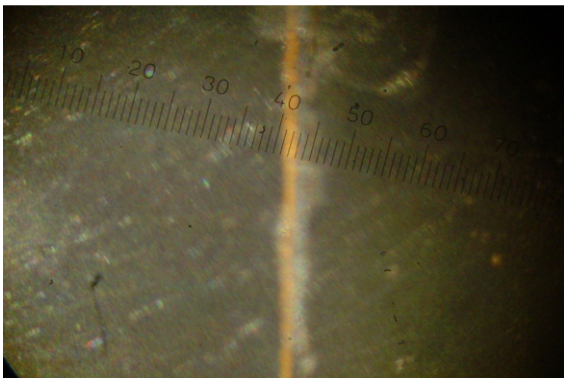
Figure 10. No evidence of corrosion on scratched line on back side of 6063/159 coupon

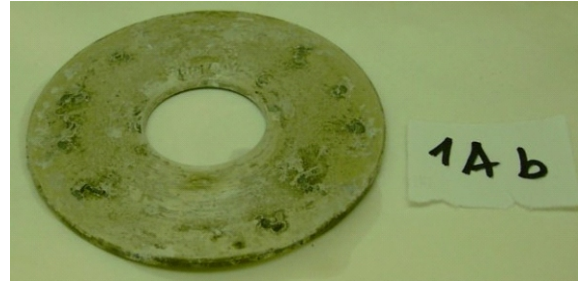
Figure 11. Back side surface of 6061/302 coupon

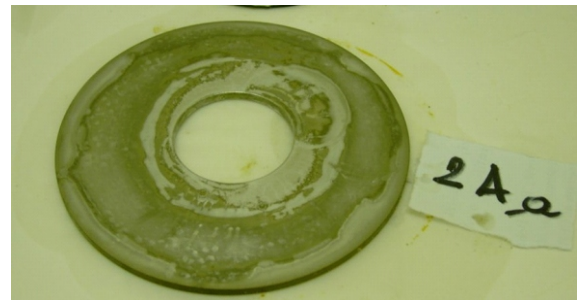
Figure 12. Front side surface of 6063/249 coupon

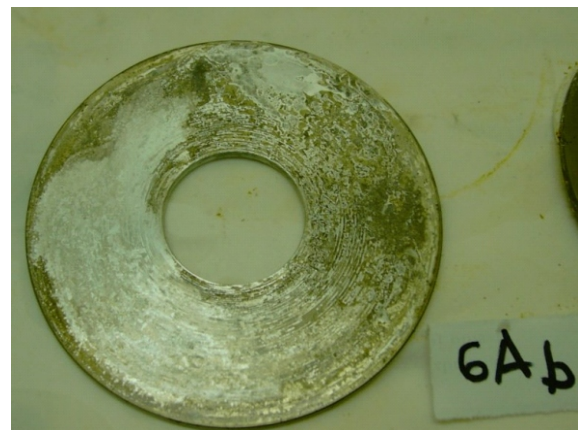
Figure 13. Back side surface of SAV-1/358 coupon

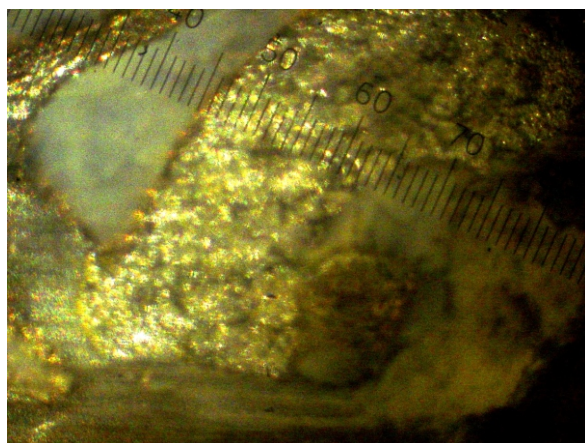
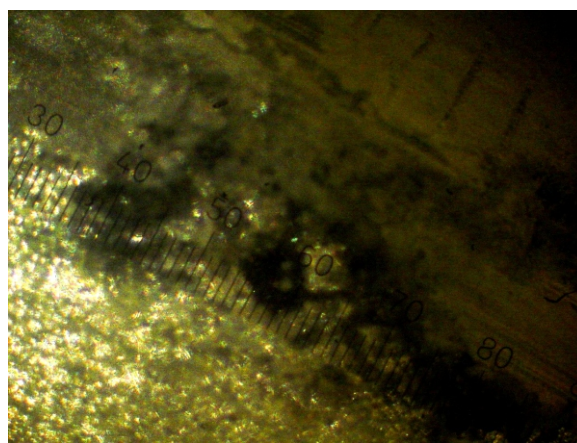
**Figure 14. Pits on front (left) and back (right) side surfaces of SAV-1/377 coupon**

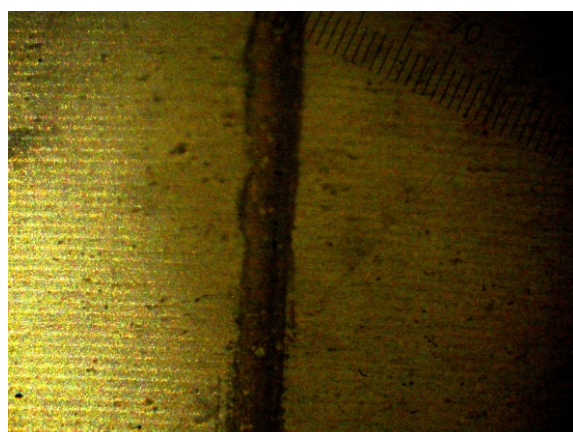
**Figure 15. No corrosion under scratched line on 6063/204 coupon**

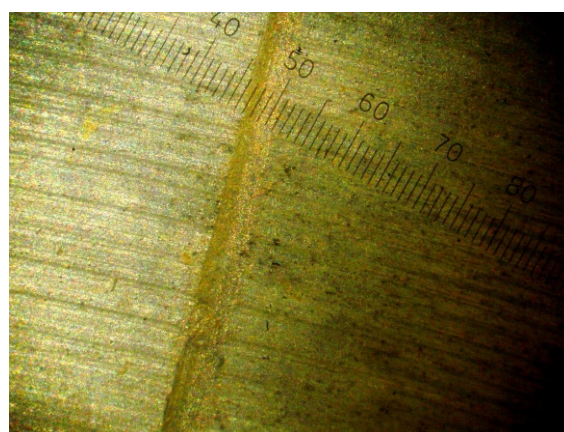
**Figure 16. No corrosion under scratched line on front side surface of SAV-1/312 coupon**

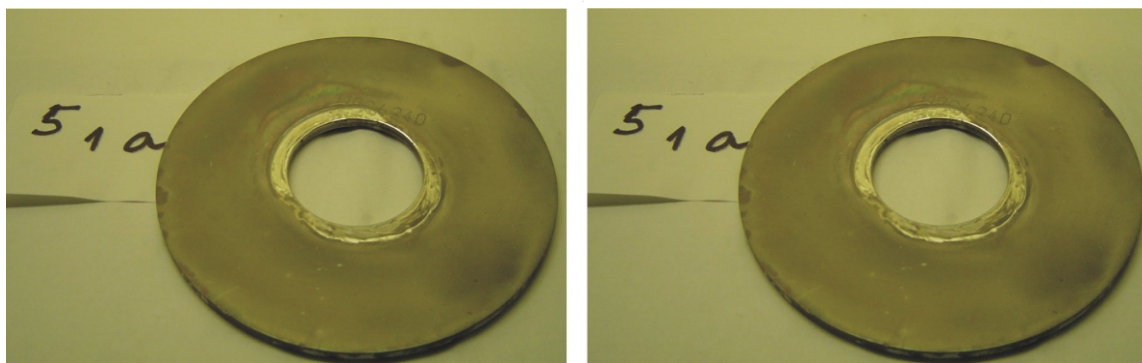
**Figure 17. Front (left) and back (right) side surfaces of 1100/240 coupons**

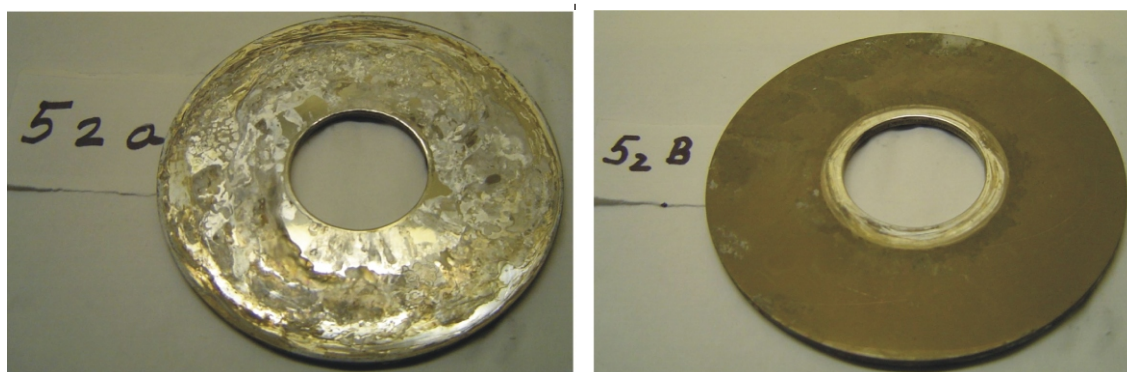
**Figure 18. Front (left) and back (right) side surfaces of 1100/244 coupons**

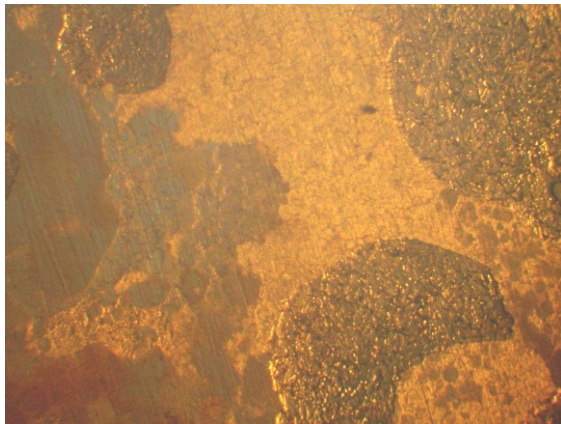
**Figure 19. Galvanic corrosion on back side of coupon 6061/142 (magnification 10)**

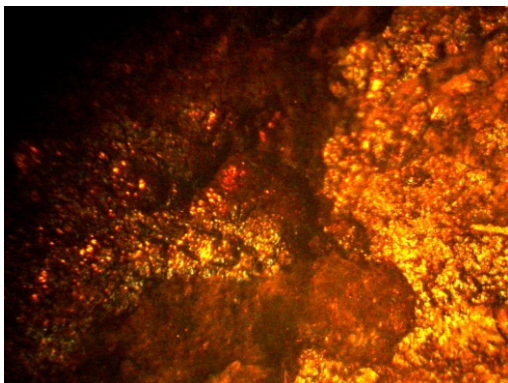
**Figure 20. Corrosion on back side of 1100/244 coupon (magnification 10)**

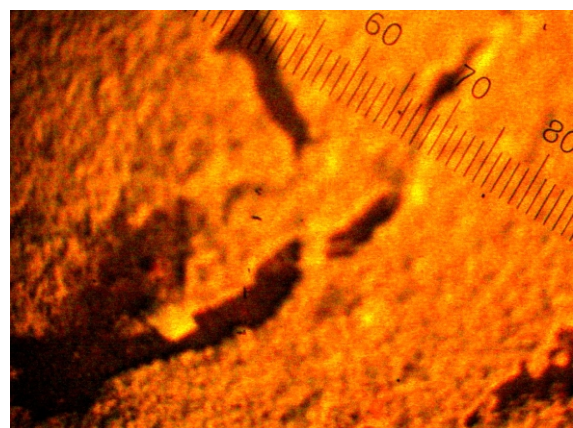
Figure 21. Corrosion on back side of 6063/198 coupon (magnification 10)

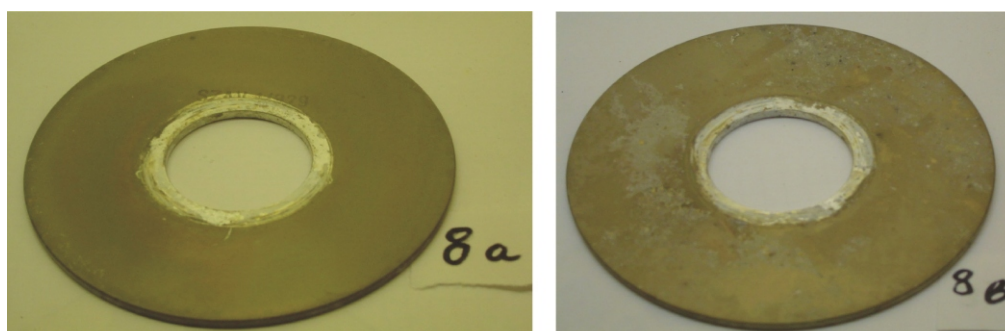
**Figure 22. Front (left) and back (right) side surfaces of SAV-1/329 coupon**

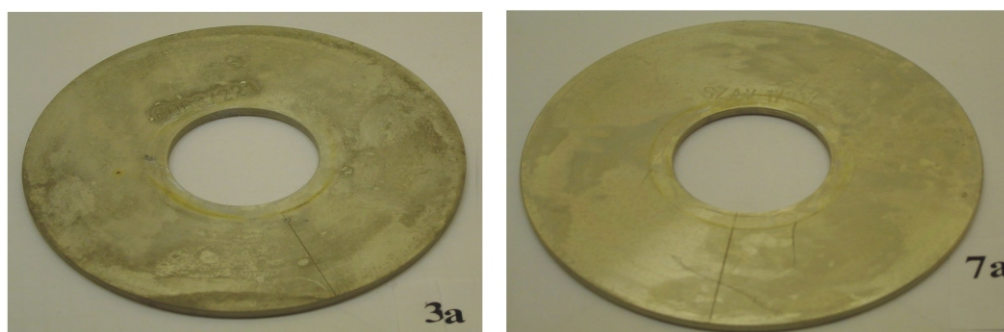
**Figure 23. Front side surfaces of 6063/221 (left) and SAV-1/317 (right) coupons**

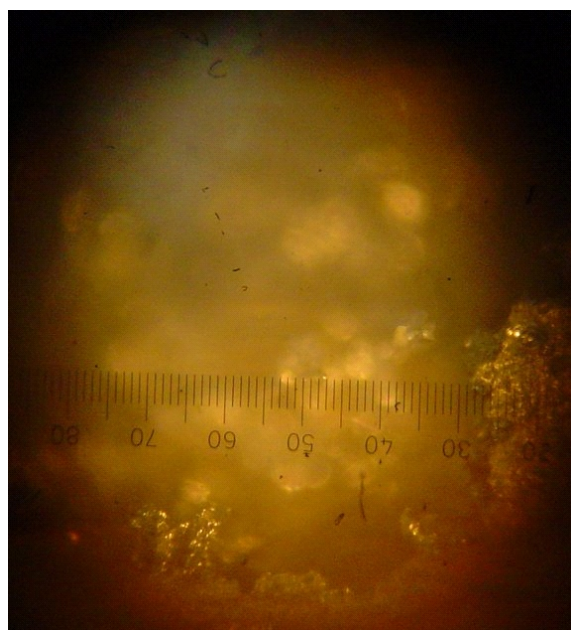
**Figure 24. Corrosion at outer edge of the coupon 6061/305**

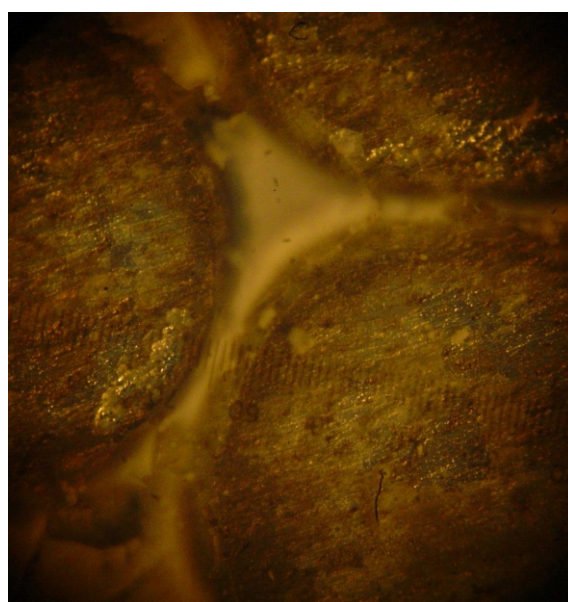
**Figure 25. Galvanic corrosion on coupled side of coupon 6063/244**

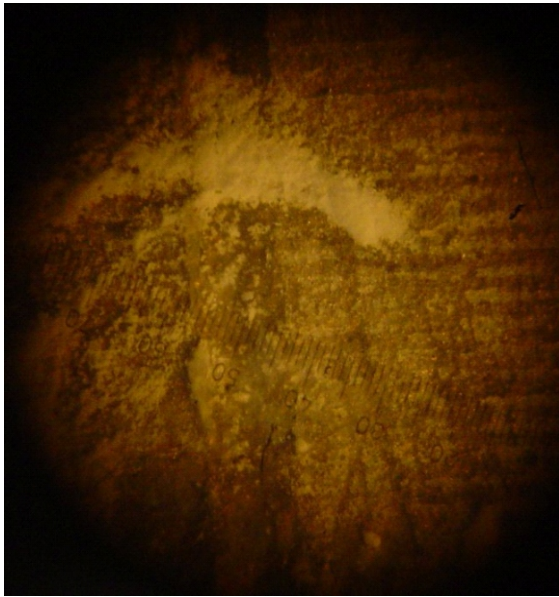
Figure 26. Corrosion on scratched line of front side of coupon 6063/221

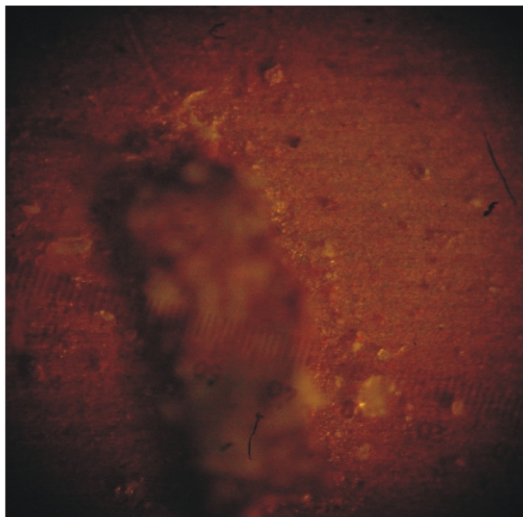
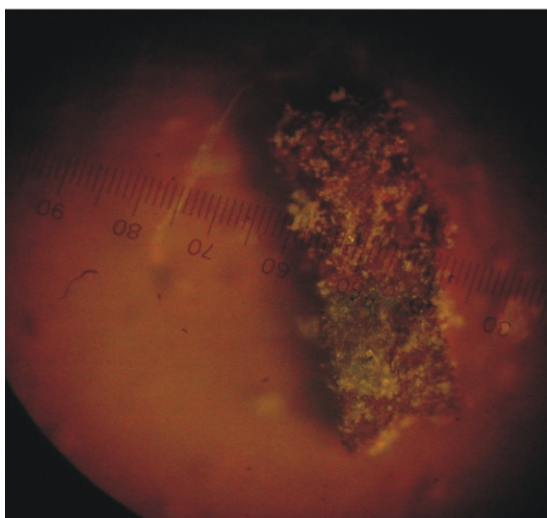
Figure 27. A large corrosion pit ("crater") on front side of coupon 6063/221

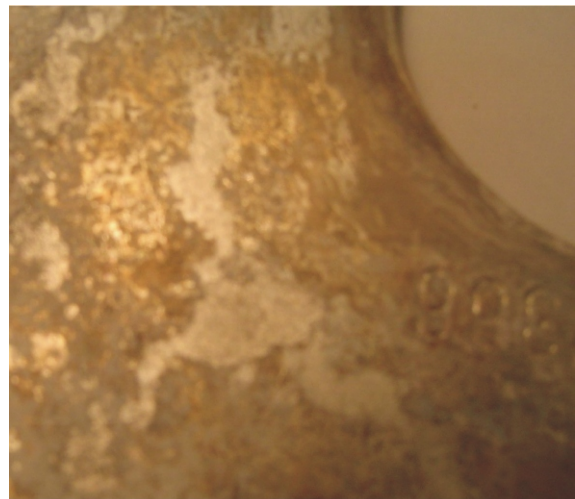
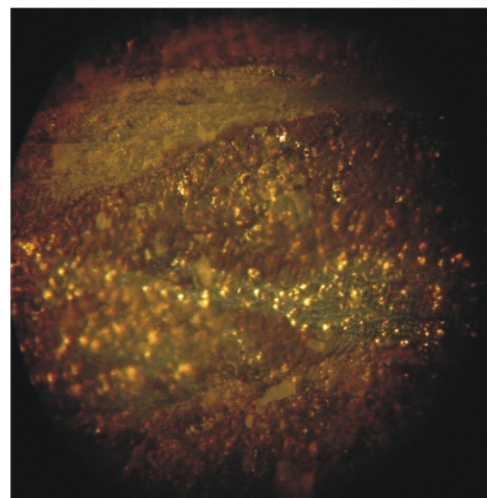
Figure 28. Crevice corrosion on back side of coupon SAV-1/366

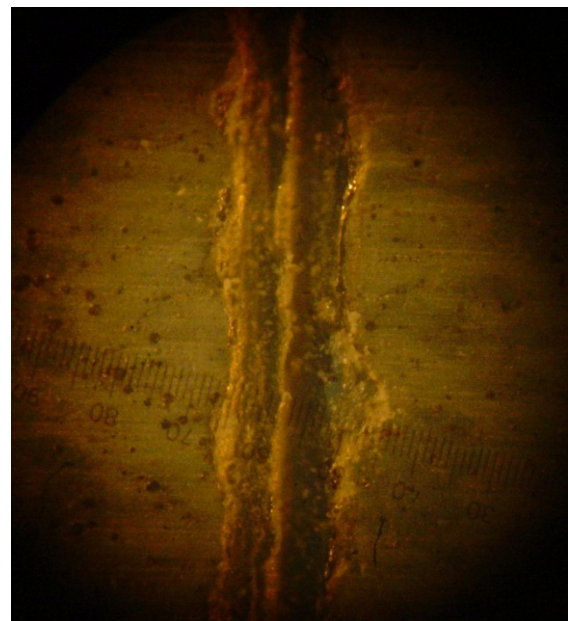
Figure 29. Corrosion on scratched line on front side of coupon SAV-1/317

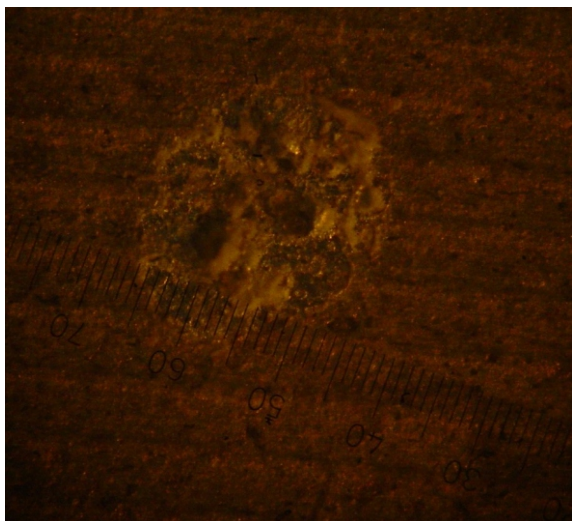
Figure 30. Initial pit corrosion on back side of coupon SAV-1/317
