# STUDY OF CORROSION OF ALUMINUM ALLOYS OF NUCLEAR PURITY IN ORDINARY WATER – PART ONE

Effects of corrosion of aluminum alloys of nuclear purity in ordinary water of the spent fuel storage pool of the RA research reactor at VINČA Institute of Nuclear Sciences has been examined in the framework of the International Atomic Energy Agency Coordinated Research Project “Corrosion of Research Reactor Aluminum-Clad Spent Fuel in Water” since 2002. The study presented in this paper comprises activities on determination and monitoring of chemical parameters and radioactivity of water and sludge in the RA spent fuel storage pool and results of the initial study of corrosion effects obtained by visual examinations of surfaces of various coupons made of aluminum alloys of nuclear purity of the test racks exposed to the pool water for a period from six months to six years.

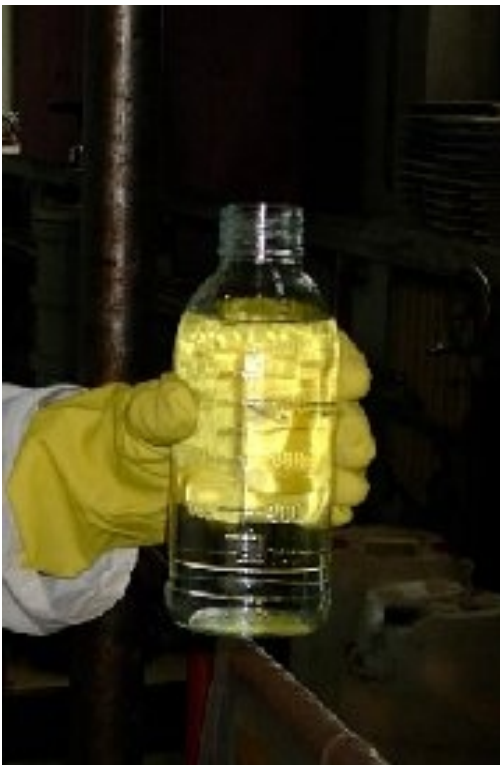
Figure 3. Water sample of RA reactor spent fuel storage pool

Water purification system of the RA spent fuel storage pool includes a pump with mechanical filter (25 m) only. The circulation rate of the water is about 60 L per minute in the basin no. 4. After sludge removal in 1996 and day-per-day operation of the purification system, clearness and visibility of the pool water were improved (fig. 3) in spite of further accumulation of dust at the water surface.

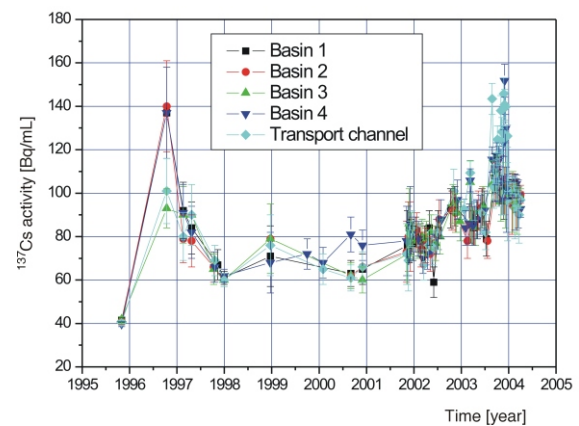
Figure 4. Specific volume activity of <sup>137</sup>Cs nuclide measured in water samples taken from the RA spent fuel storage pool

Peaks of measured <sup>137</sup>Cs specific (volume) activity in the RA spent fuel storage pool, shown in fig. 4, are attributed to increased operator-related activities in the pool basins, e. g., sludge removal in 1996, drilling of ALBs in 2000 and 2001 and examination of SSCHs in 2003. These man-related activities, carried out in the basins, have contributed to rising of suspension of the sludge in the pool water. Thus consequently has led to an increased value of <sup>137</sup>Cs specific volume activity in water samples, since the <sup>137</sup>Cs nuclide is bounded mainly in sludge.

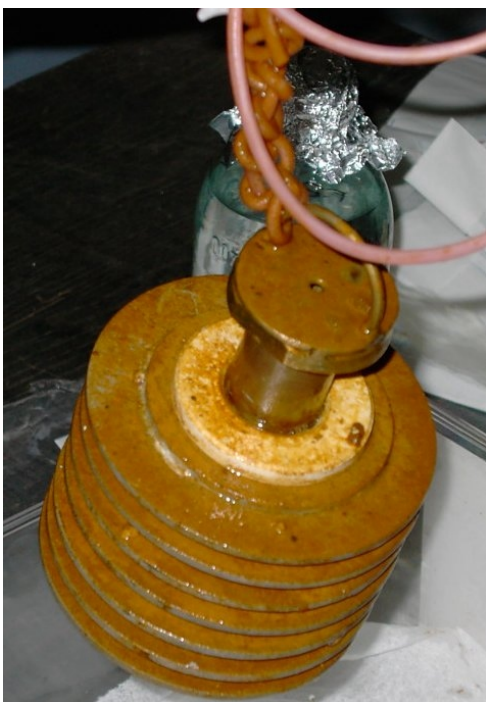
**Figure 7.** Rack#1/CRP-I after 72 months of exposition time

Rack#1 from CRP-I was received by the VINČA Institute in 1996 and assembled according to the IAEA instructions. It contains only the couples of coupons: smaller diameter aluminum alloy or stainless steel coupons at the top are coupled to aluminum alloy coupons at the bottom of the couple. The rack was exposed to the water in the basin no. 4 of the RA spent fuel storage pool for 72 months, from July 1996 to July 2002. It was taken out on July 30, 2002 (fig. 7) and temporarily placed in a glass beaker partially covered by pool water with the aim to obtain instructions for its disassembling and coupons cleaning from large quantity of sediments accumulated.

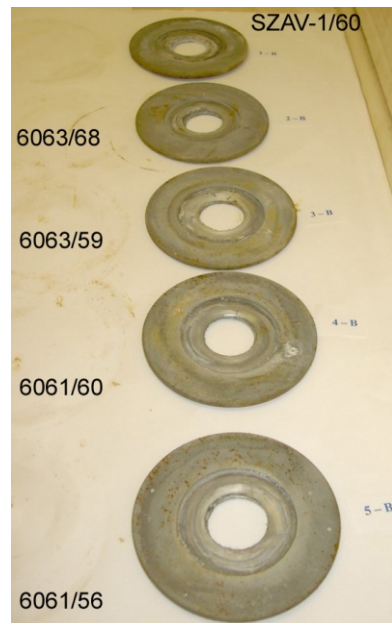
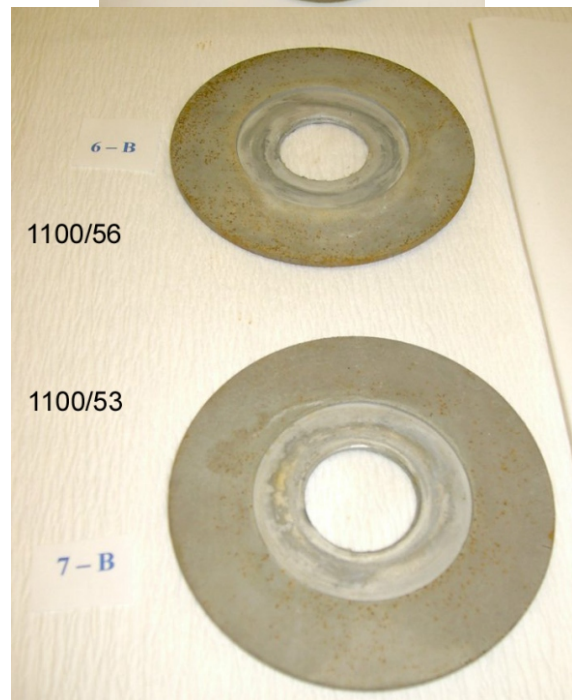
Figure 10. Backside (B) of coupons of disassembled Rack#1/CRP-I

were removed from the Rack#1/CRP-I according to the IAEA Test Protocol. It was very hard to separate coupled coupons and in few cases a tool has to be applied. Photographs of the top – “the front” (fig. 9, A) and the bottom – “the back” (fig. 10, B) sides of each coupon are presented. The number beside a coupon corresponds to the type of aluminum alloy or stainless steel. The first – left number, corresponds to the upper coupon, while the second – right number, corresponds to the lower coupon of the couple. Label “SZAV”, the Hungarian spelling for SAV-1 aluminum alloy, is used at the photographs.

Since the front side of each coupon was covered by dark-red sediment (fig. 9), effects of corrosion process could not be seen without cleaning the surfaces. Small white sediments (like jelly-mushroom type sludge) at the front side of few coupons (fig. 9) were noted. Some of these sediments were collected for further analysis. The backside of the coupons was not covered by sediment (figs. 8 and 10) and effects of the corrosion process were noted. Pitting, as a main localized form of corrosion of aluminum in water, was seen at the backside of the surfaces of all coupons. Spots of different shades of gray and black color (assumed to be aluminum-oxide) were observed at coupons too.

In an on-line cooperation with an aluminum corrosion expert, Mr. Lalgudi Ramanathan, from IPEN, Brazil, an iterative cleaning of dried coupons of the Rack#1/CRP-I was performed in a step by step manner. In the first step, coupons were treated by 5% phosphoric acid solution according to the IAEA Test Protocol for 3 minutes only. Later, in further steps, the cleaning time was increased gradually (up to 10 minutes) with the aim to remove dried

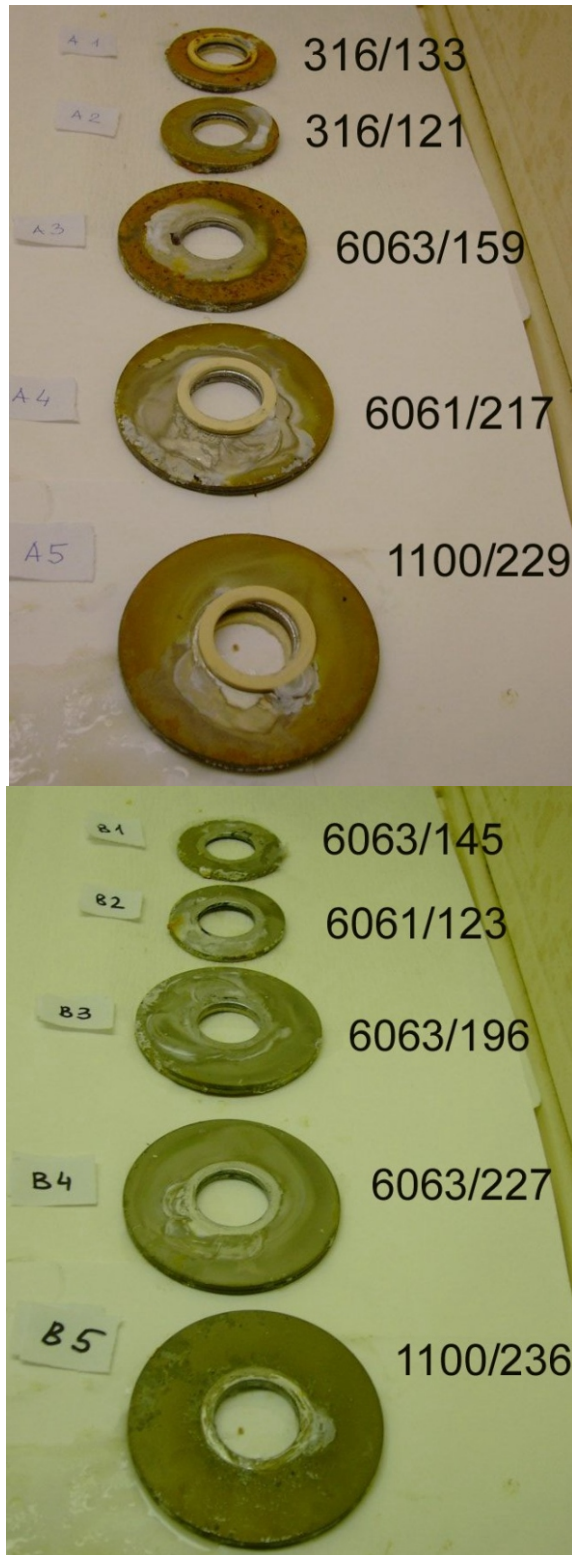
Figure 17. Front side (A) and backside (B) of coupons of disassembled Rack#2.1/CRP-I

Rack#2.1/CRP-I showed that the backside of the coupons was not covered with sediment, as it was the case at the front side of coupons.

Protocol. It was very hard to separate coupled coupons and a tool was used in few cases. Photographs of the front (A) and the back (B) side of each coupon are presented (fig. 17) with numbers corresponding to the type of aluminum alloy or stainless steel.

Dark-red sediments covered the front side of coupons and effects of corrosion process could not be seen without cleaning surfaces. White sediments (like jelly-mushroom type sludge) at the front side of few coupons (fig. 18) and the supporter of the Rack#2.1/CRP-I were noted and collected for further analysis. Sediments did not cover the backside of the coupons and effects of corrosion process were noted. Pitting, as a main localized form of corrosion of aluminum in water, was seen at surfaces of all coupons, except one that was pre-oxidized during manufacturing process. Spots of different shades of gray and black color (assumed to be aluminum-oxide) were observed at coupons, too.

The coupons were treated by 5% phosphoric acid solution according to the IAEA Test Protocol for about 1-2 minutes to remove sediments and clean the surfaces. After that process, the coupons were examined visually with the aim to study corrosion effects and the results will be given in a table later.

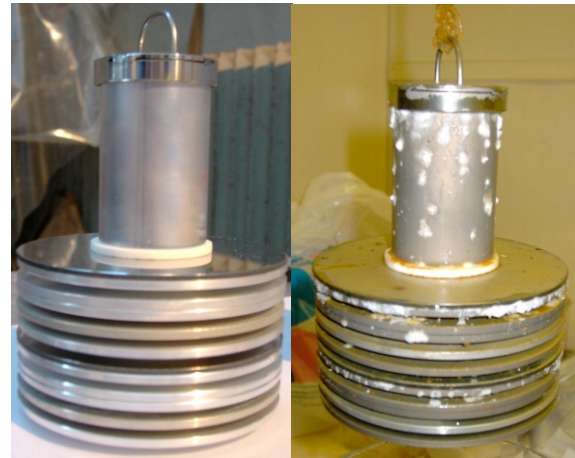
Figure 22. Rack#1/CRP-II before immersion and after 6 months of exposition time

The pH factor, measured by using pH paper just after the Rack#1/CRP-II was withdrawn at wet surfaces of the coupons, was 6.5 at the top and middle coupons and 7 at the bottom coupon. Gamma-ray dose rate measured in the vicinity of the Rack#1/CRP-II was about  $3 \mu\text{Sv/h}$ . The pH factor of the water in basin No. 3 was 7.5.

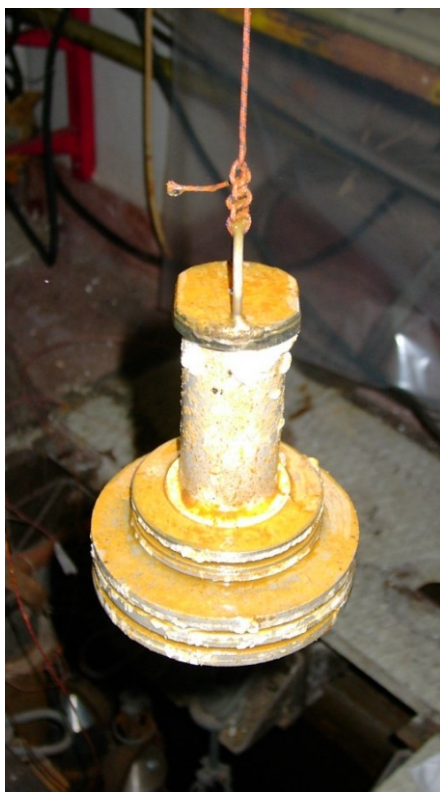
Figure 30. Rack#2.2/CRP-I after 24 months of exposition time

The pH factor, measured just after the Rack#2.2/CRP-I was withdrawn at the wet surfaces of the coupons, was from 5.6 to 5.9. Gamma-ray dose rate in the vicinity of the Rack#2.2/CRP-I was about  $3.5 \mu\text{Sv/h}$ . Value of pH (obtained by using pH paper) on the external front or back surfaces of the middle coupons was 6.5, while pH factor measured deep inside the rack, between coupons, was 5.3. The pH factor of water in basin No. 1 was 7.0.

Initial visual examination of the Rack#2.2/CRP-I showed the same effects noted at all racks. The backside of the coupons was not covered by sediment, as it was the case at the front sides. The Rack#2.2/CRP-I was disassembled and all coupons were removed according to the IAEA Test Protocol. It was difficult to separate coupled coupons and a tool was used. Photographs of the front (fig. 31, A) side of each top coupon (including coupons in couples) are presented. In the case of couples, the surface of the coupled side of the bottom coupon is shown. The number beside a coupon corresponds to the type of aluminum alloy or stainless steel.

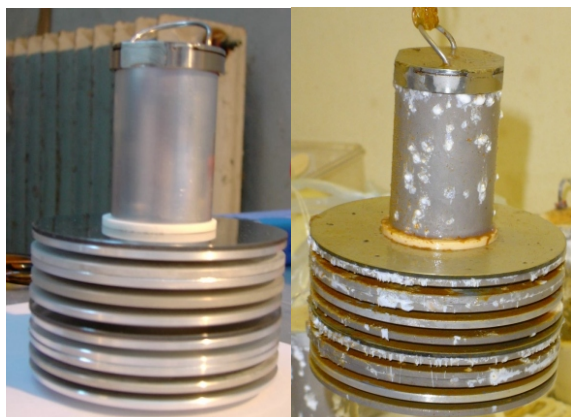
Figure 38. Rack#2/CRP-II before immersion and after 12 months of exposition time

Value of the pH factor, measured by using pH paper, immediately after the Rack#2/CRP-II was withdrawn, at wet surfaces of the coupons, was 6.5 at the top and middle coupons and 6.0 at the bottom coupon. Gamma-ray dose rate measured in the vicinity of the Rack#2/CRP-II was about  $4 \mu\text{Sv/h}$ . The pH factor of water in basin No. 2 was about 7.5. The first visual examination of the Rack#2/CRP-II showed that backside of the coupons were not covered by sludge deposits. Sediments covered only the front side of the coupons.

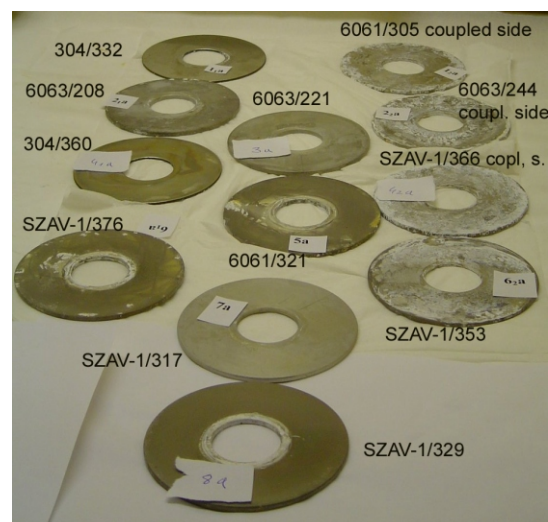
Figure 39. Front side (A) of coupons of disassembled Rack#2/CRP-II

The Rack#2/CRP-II was disassembled and all coupons were removed according to the IAEA Test Protocol. Coupled coupons were difficult to separate and a tool was used in few cases. Photographs of the front (fig. 39, A) side of each coupon (including coupons in couples) are presented. In the case of couples, the surface of the coupled side of the bottom coupon is shown. The number beside a coupon corresponds to the type of aluminum alloy or stainless steel.

The coupons were treated by 5% phosphoric acid solution immediately according to the IAEA Test Protocol for about 3 minutes with the aim to remove sediments and clean the surfaces. After that process, the coupons were examined visually with the aim to study corrosion effects. Pitting, as the main localized form of corrosion of aluminum in water, was seen at the surface of almost all coupons. Spots of different shades of gray and black color (assumed to be aluminum-oxide) were observed at
